24 faults and their causes

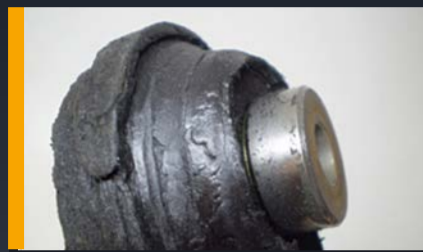
Alfa Romeo / Fiat / Opel / Saab

Fault: The idler has melted all round.
All: 1.9 JTD
Cause: The reverse of the timing belt has overheated because of a seized water pump and has destroyed the lagging.

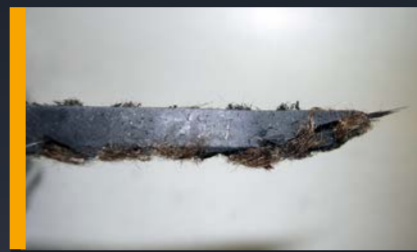
Audi / VW / Seat / Skoda

Fault: The belt for the drive mechanism has torn because of the lack of extra width.
All: 1.4- /1.6-16V
Cause: The tensioning pulley has become misaligned because the bracket was not correctly engaged.

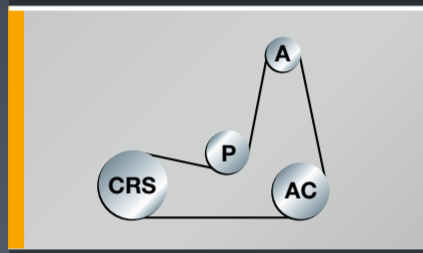
Audi / VW / Seat / Skoda

Fault: The belt length has changed from 6 PK 1140 to 6 PK 1070 and cannot be fitted directly.
All: 1.6 / 2.0 TDI
Cause: An additional tensioning element (038903315AH) has to be used instead of the idler.

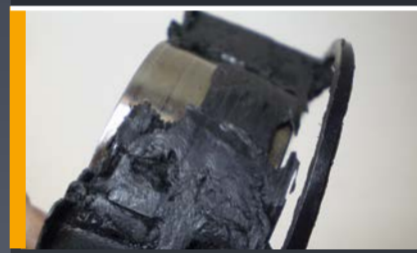
Citroen / Fiat / Ford / Mazda / Mini / Peugeot / Volvo

Fault: The idler shows wear marks.
All: 1.6 Diesel 9 H engines
Cause: The cladding has rubbed on the front of the roller and prevented it from rotating freely.

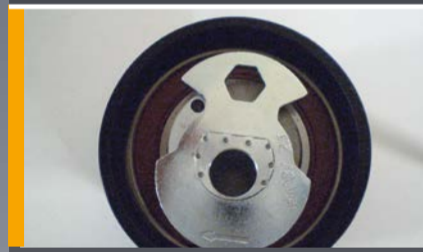
Ford

Fault: The pulley in the kit is of a different design.
Transit 2.5 DI
Cause: Only the new design is now used.

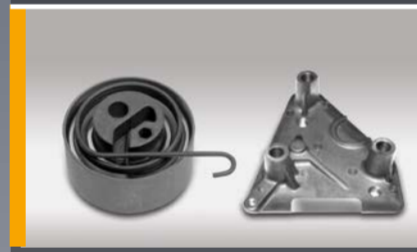
Opel

Fault: The pulley in the kit is of a different design.
All: 1.7 DTI up to engine no. 328703
Cause: Only the new pulley design is now used. The modified engine bracket must be used with this.

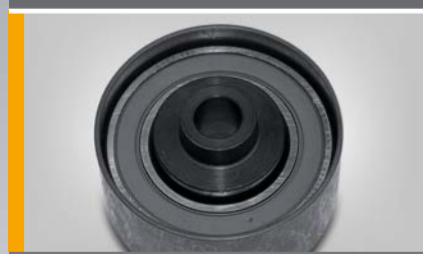
Opel / GM

Fault: The pulley in the kit is of a different design.
All: 1.7 D
Cause: Only the new pulley design is now used. The sheet metal design is no longer used.

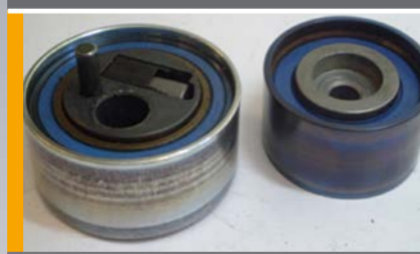
Opel / Renault / Saab

Fault: The belt components become overheated after a short period of running (pulley seizure).
All: 3.0 DTI V6
Cause: The upper idler must be fitted with the projecting inner flange facing towards the engine.

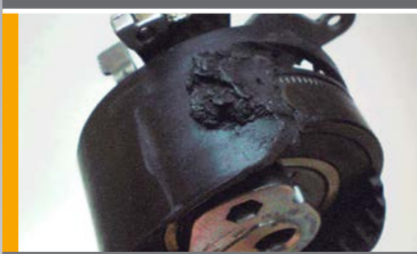
Renault

Fault: The tensioning roller shows pronounced indications of melting on the lagging.
All: 1.2-16V
Cause: Wrong rotational direction when tensioning.

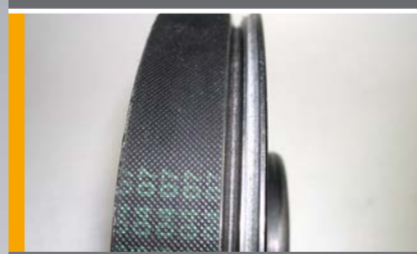
Renault

Fault: The belt frays at the sides.
All: 1.4- / 1.6-16V
Cause: From MY 2001 onwards a PK 1750 must be used, and the inner groove of the pulley remains unoccupied.

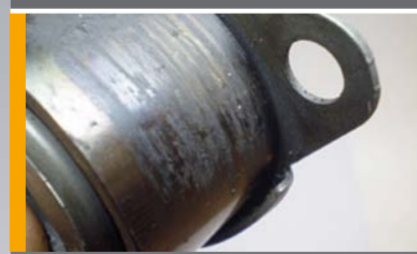
Renault

Fault: The tensioning pulley becomes misaligned under the load on the bracket plate and seizes.
All: 1.7 / 1.8 / 2.0 and 1.9 D / DTI / DCI
Cause: After adjustment, the tensioning pulley has to be tightened to 40 - 50 Nm, and the hole on the arm has to be correctly positioned.

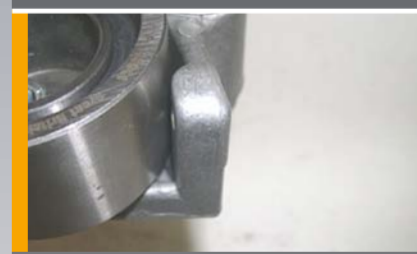
Rover MG

Fault: The tensioning pulley becomes misaligned under the load on the bracket and seizes.
All: 2.0 / 2.5 V6
Cause: The tensioning pulley is only initially fitted in the factory and has to be tightened to the arm to 40 - 50 Nm after adjustment.
